# MRI MAGNETIC RESONANCE IMAGING

TARGETED DRUG DELIVERY TECHNICAL SERVICES

Medtronic

Information for prescribers (includes MRI eligibility  
information)

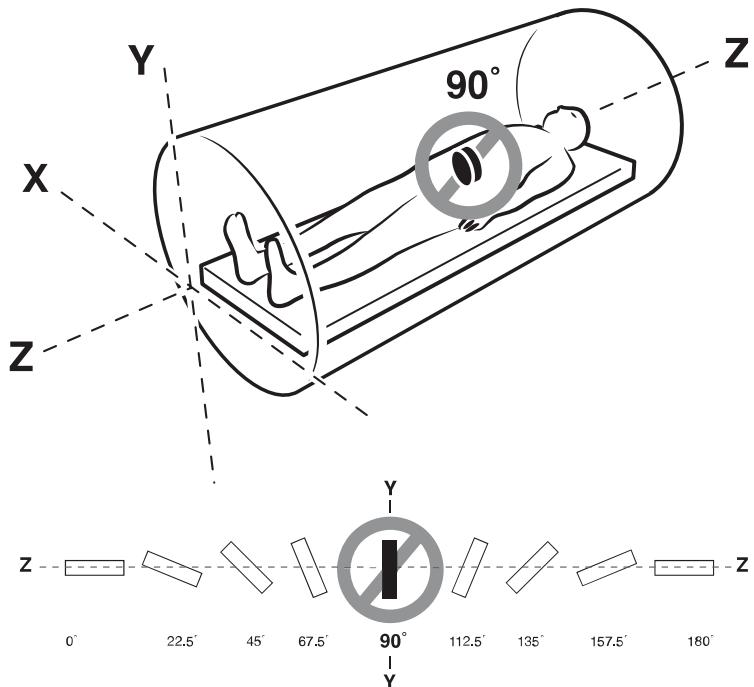
**Figure 1. Pump positions in relation to z-axis MRI orientations**

90° alignment of an implanted pump with the z axis (Figure 1) of 1.5-T and 3.0-T horizontal, closed-bore magnetic resonance imaging (MRI) scanners can cause MRI-

induced demagnetization of the internal pump motor magnets, which can result in permanent, nonrecoverable stoppage of the pump. This is due to the orientation of the pump with respect to the magnetic field of a horizontal, closed-bore MRI system. SynchroMed II pump performance has not been established using other types of MRI scanners such as open-sided or standing MRI.

**Note:** If the pump face is oriented at 90° to the z axis, the refill port would be facing towards the patient's feet or head.

Prior to MRI, confirm the pump is not oriented 90° with respect to the z axis of the MRI scanner (see Figure 1). Also, determine if the patient implanted with a SynchroMed II pump can safely be deprived of drug delivery. If the patient cannot be safely deprived of drug delivery, alternative delivery methods for the drug can be used during the time required for the MRI scan. If there is concern that depriving the patient of drug delivery

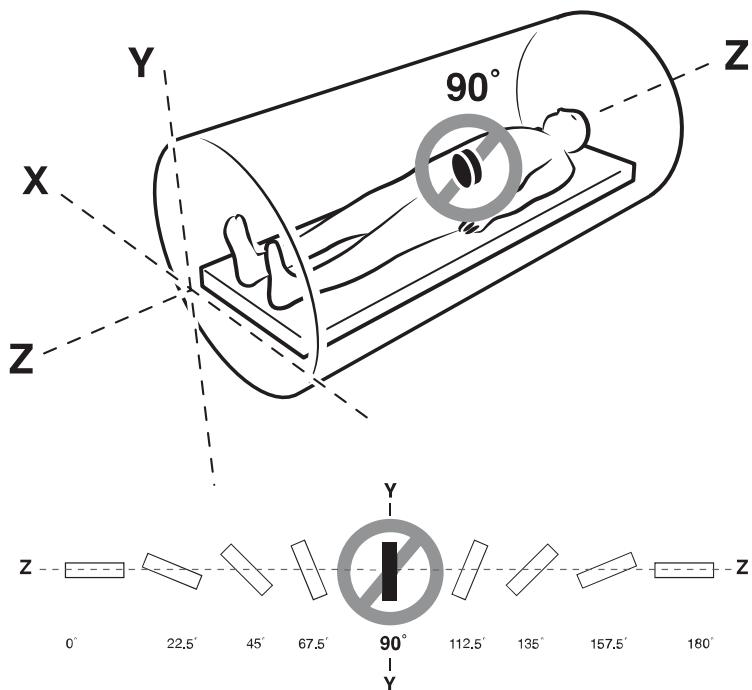
**Figure 2.** Pump positions in relation to z-axis MRI orientations

90° alignment of an implanted pump with the z axis (Figure 2) of 1.5-T and 3.0-T horizontal, closed-bore magnetic resonance imaging (MRI) scanners can cause MRI-induced demagnetization of the internal pump motor magnets, which can result in permanent, nonrecoverable stoppage of the pump. This is due to the orientation of the pump with respect to the magnetic field of a horizontal, closed-bore MRI system. SynchroMed EL pump performance has not been established using other types of MRI scanners such as open-sided or standing MRI.

**Note:** If the pump face is oriented at 90° to the z axis, the refill port would be facing towards the patient's feet or head.

Prior to MRI, the physician should ensure the pump is not oriented 90° with respect to the z axis of the MRI scanner (see Figure 2). The physician should also determine if the patient implanted with a SynchroMed EL pump can safely be deprived of drug delivery. If the patient cannot be safely deprived of drug delivery, alternative delivery methods for the drug can be used during the time required for the MRI scan. If there is concern that depriving the patient of drug delivery may be unsafe for the patient during the MRI procedure, medical supervision should be provided while the MRI is conducted.
